**NASA TECHNICAL
MEMORANDUM**

NASA TM X-52290

CENTAUR AC-6 NOSE FAIRING SEPARATION TESTS

by Jack C. Humphrey and Charles W. Eastwood, Jr.

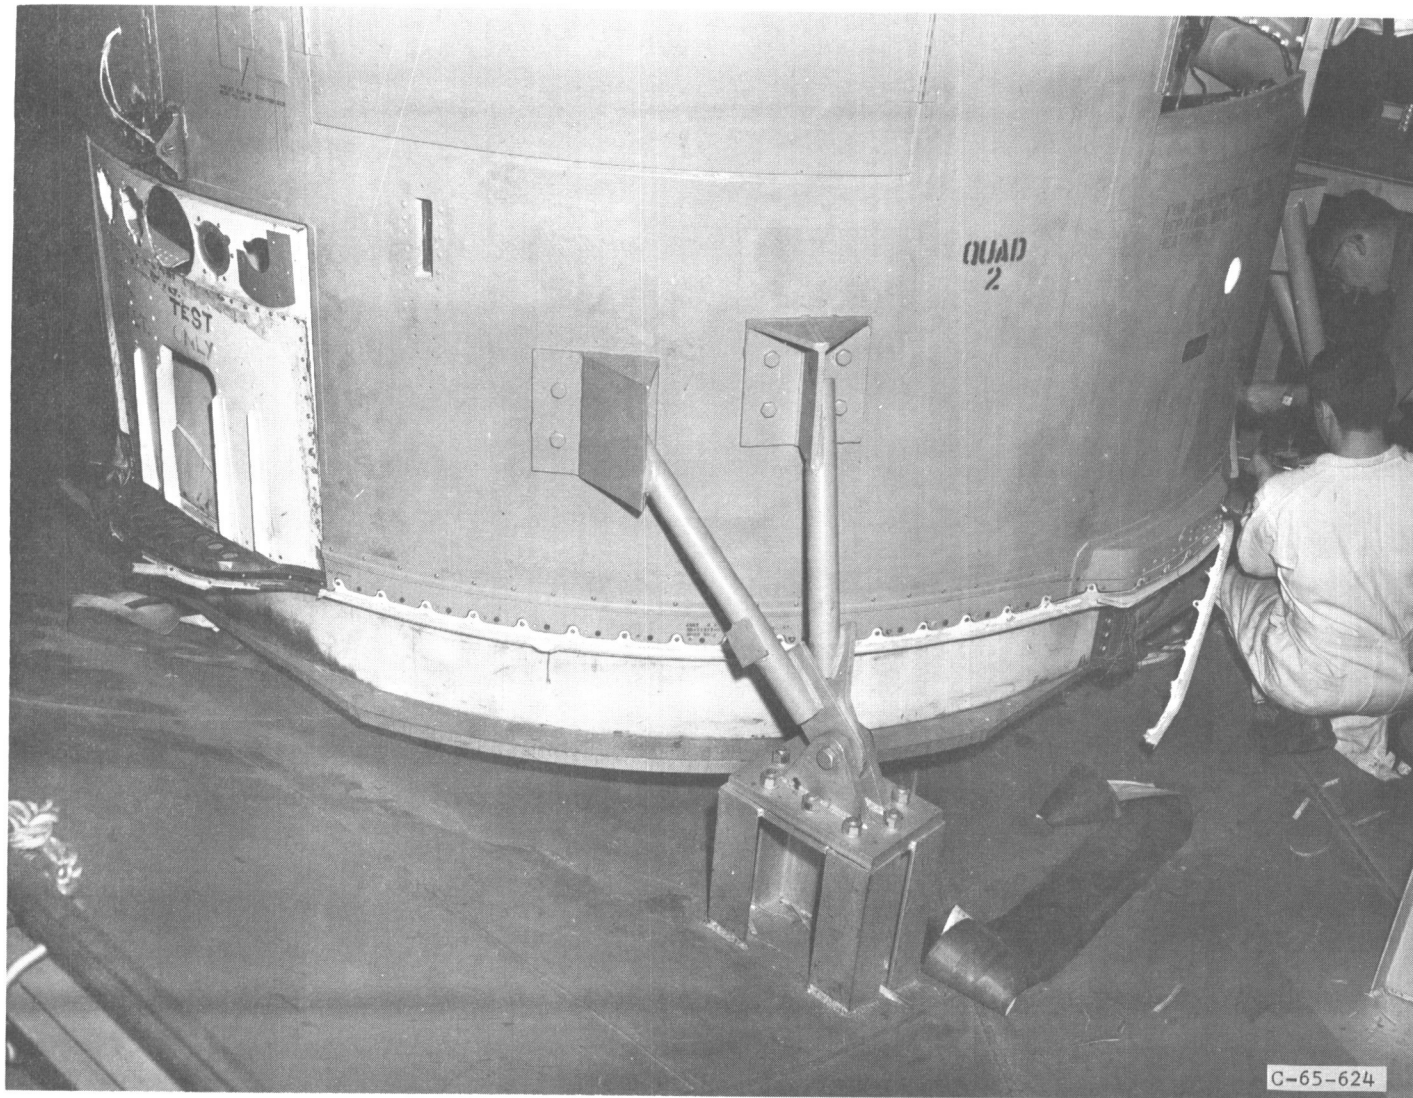
Figure 33. - Shaped charge test damage, LA-1A.

Although the shaped charge completely separated the fairings from the vehicle, it also caused damage to the skirt assembly (a plastic structure protecting the shaped charge) as shown in figure 10. The effect of the explosion was to force the skirt outward and thus to shear inserts. These inserts were glued to the foamed plastic body of the skirt and were used to provide bearings for the bolts holding the skirt to the 219 ring. Figure 43 shows the developed surface of the skirts used in each of the tests and indicates the position of each of the bolt-insert points on the skirts. This figure lists all damage seen after each of the shaped charges were fired. As can be seen in test LA-1A and LA-2A, very few of the inserts were intact after the test. In test LA-1A five of the insert-bolt points were undamaged and in test LA-2A, eleven were undamaged. Damage varied from partial cracking of the glue joint between the insert and the skirt body as shown by the symbol marked "incipient failure" to bolts completely blown from their thread fasteners or inserts with no effective glue joint, as shown by the symbol marked "failure". Test LA-2B was made with the skirt body used in test LA-2A. New inserts were glued in the skirt using a mixture containing 50

(a) After the removal of skirt.

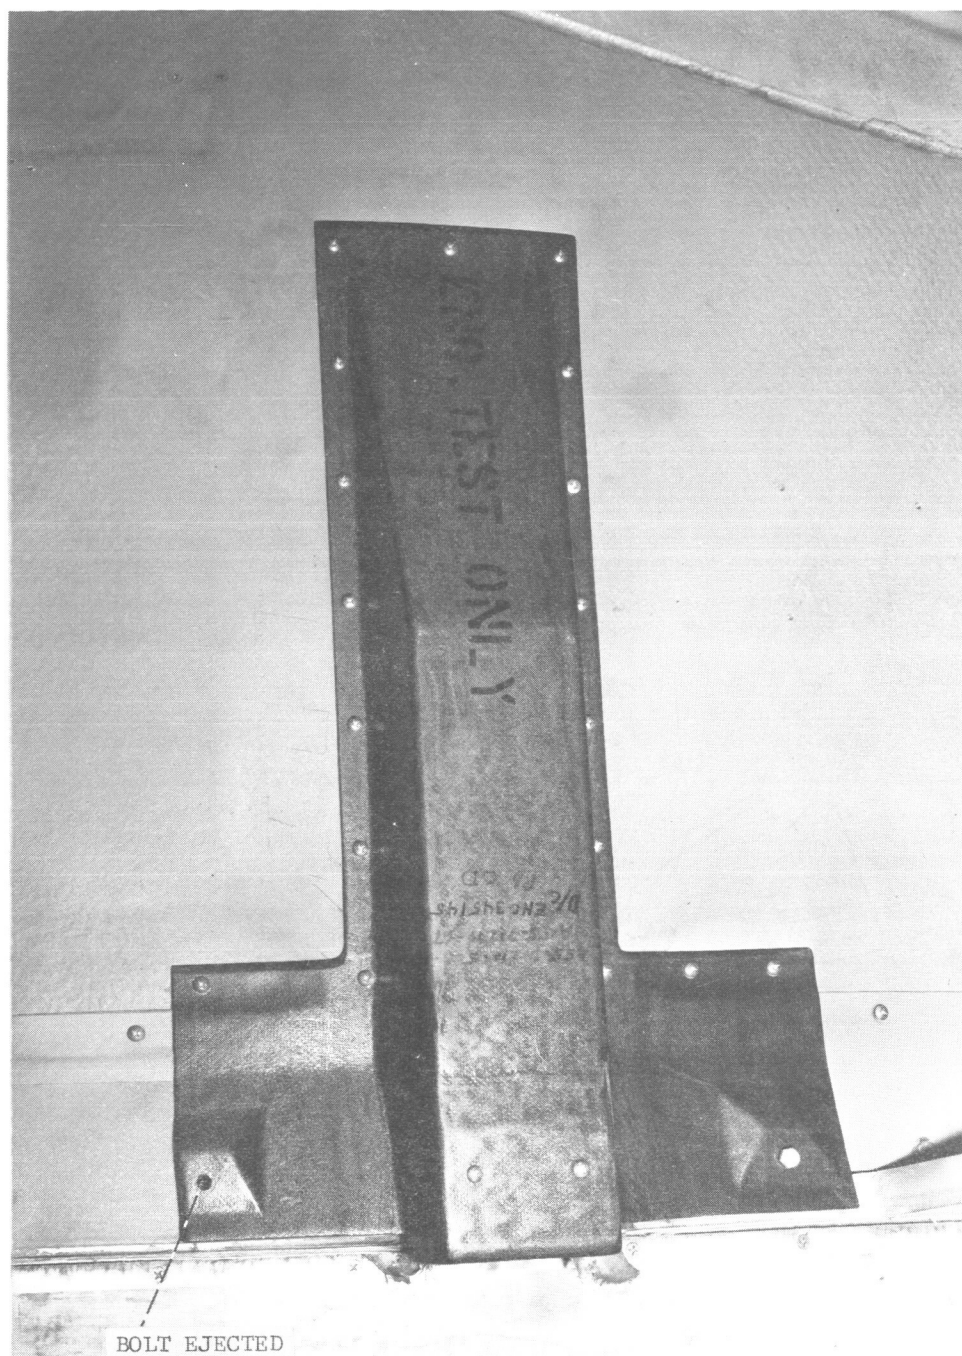
Figure 33. - Continued. Shaped charge test damage, 1A-1A.

Damage was also sustained by the fairing used to cover the shaped charge detonators and by the detonators. Figure 33b shows the detonator fairing after the explosion. Some damage to the detonator fairing structural fiberglass was observed after the first two tests, but this was eliminated by adding more layers to the fiberglass. Bolts were completely ejected by the explosion during some of the tests, but use of longer bolts eliminated this problem. During the first three tests, the screw holding the dual detonator to a plastic mounting plate failed in tension. Views of this failure are shown in figure 33d and figure 44. Larger screws were used in test LA-4B and no failure occurred.

(b) Detonator fairing.

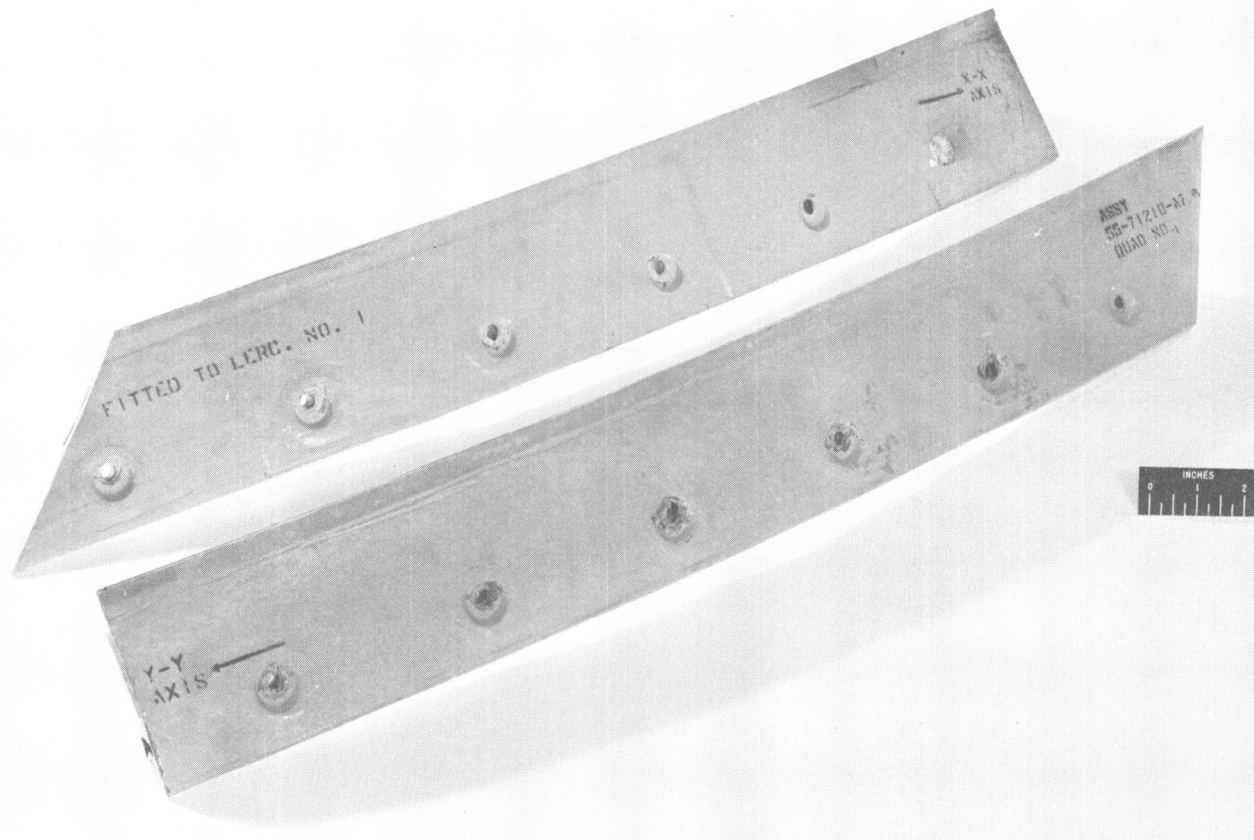
parts by weight of Epon 828, 50 parts by weight of Versamid, and 10 parts by weight of hardener. This mixture was very fluid and probably held the inserts better than the adhesive used in tests LA-2A, thus partially accounting for the improved performance in tests LA-2B. In test LA-2B, washers were placed under the head of the bolts to give a larger bearing area than that provided by the inserts. Washers in quads I, III, and IV were of 0.562 inch diameter while those in quad II were of 0.625 inch diameter. Greatly improved performance was noted in all parts of the skirt but the skirt in the quad II area with the 0.625 inch washers had 93 percent undamaged connection points while the skirts in the other quads had only 67 percent undamaged connection points. Test LA-4B was run with 0.625 inch washers under all bolt heads and had 94 percent of the connection points undamaged, the damaged connection points had only incipient failure.

(c) Damaged inserts on the skirt.
Figure 33. - Continued. Shaped charge test damage, 1A-1A.

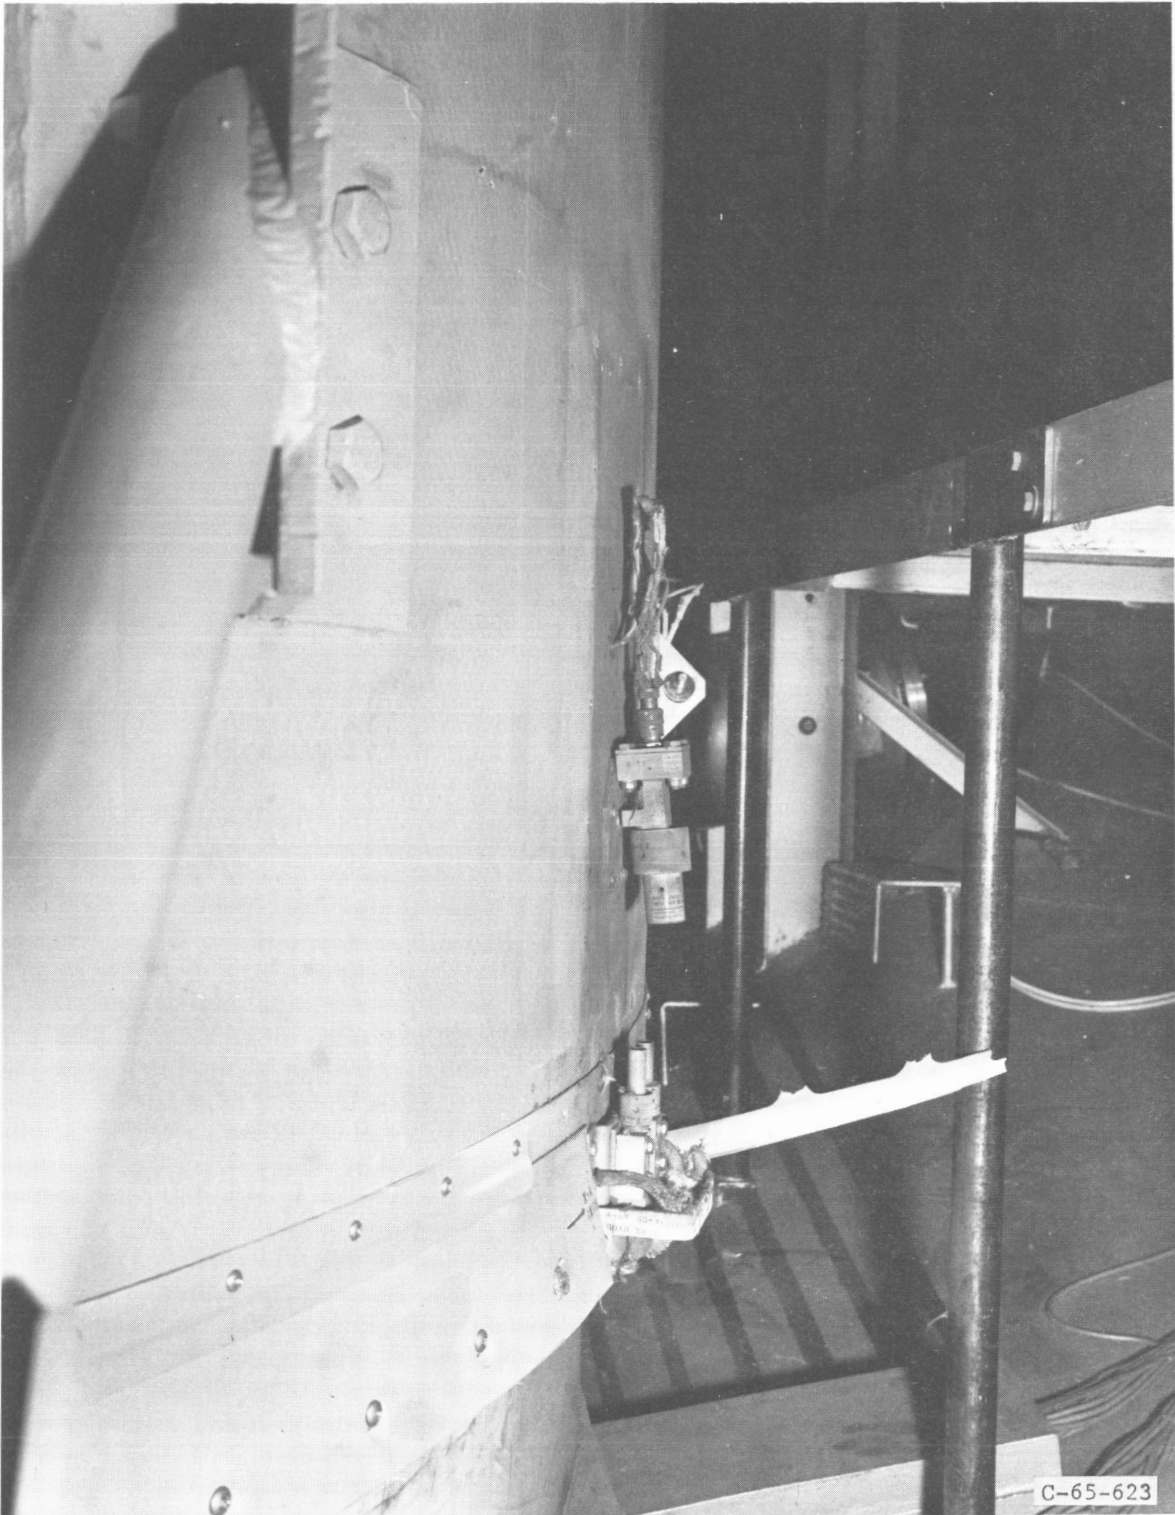
Figure 33. - Continued. Shaped charge test damage, LA-1A.

(d) Damage to the detonator mount.

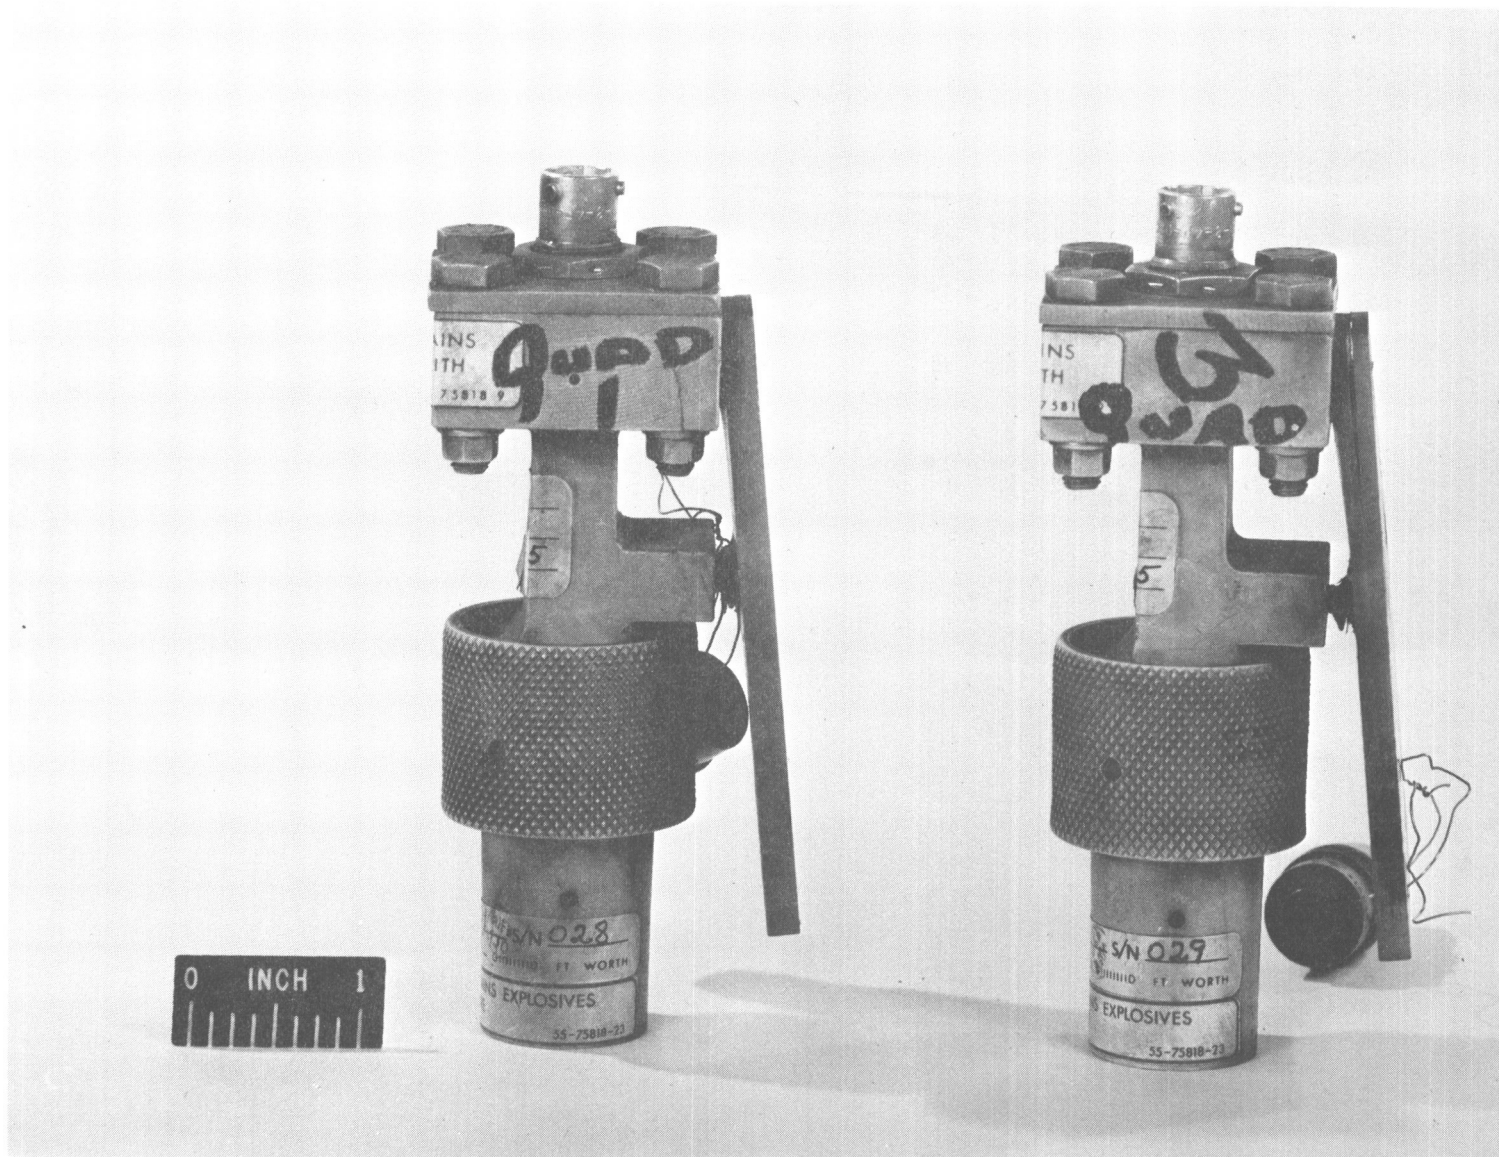
Figure 33. - Concluded. Shaped charge test damage, LA-1A.

(e) Closeup of the damage to the detonator mount.

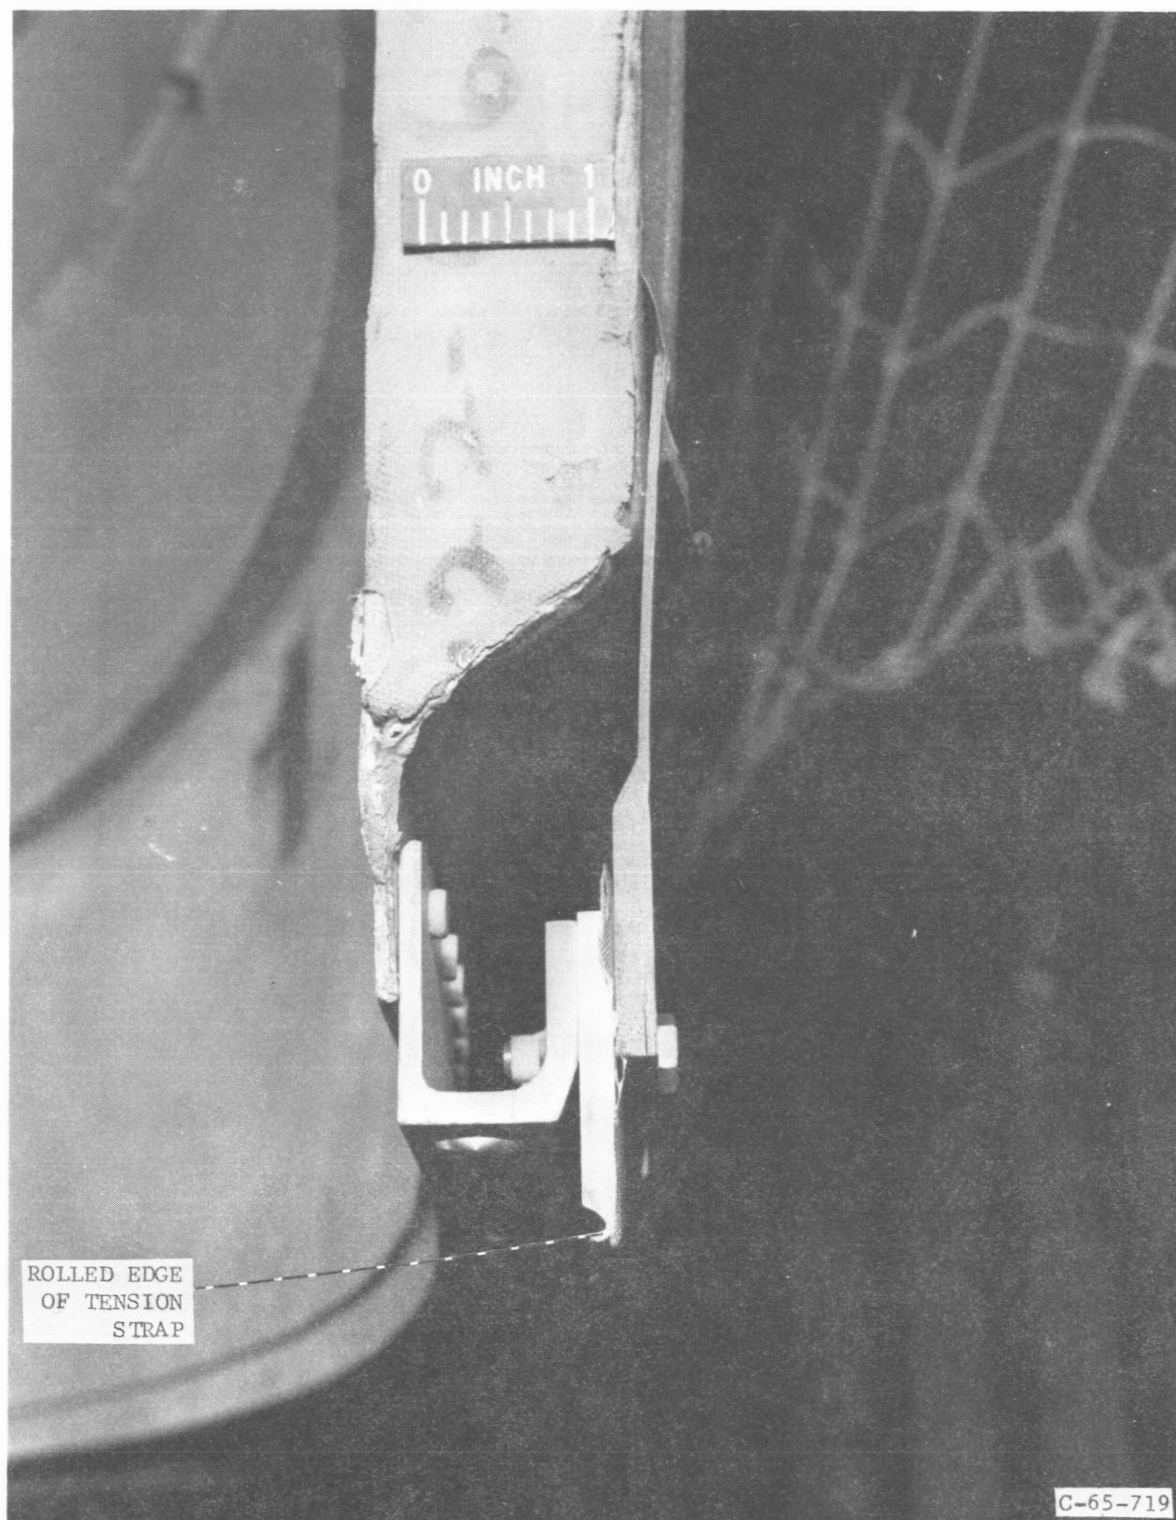
seal was placed under the tension tie, the tension tie and the seal were both completely cut so that separation of the nose fairing could be accomplished. In shaped charge tests LA-1A, LA-2A, and LA-2B, the tension ties were examined after being cut and were found to have a rolled over edge at the cut as shown in figure 34.

Figure 34. - Tension strap after being cut by the shaped charge, test IA-1A.

In test LA-2A, the rolled edge was cracked at its junction with the main body of the tension strap and a possibility existed that it could break off and provide flying strips of metal that might endanger the payload. Figure 60 shows a detailed cross section of the groove under the shaped charge for the tension ties used in tests LA-1A, LA-2A, and LA-2B and for the redesigned tension tie groove used in test LA-4B. In the original groove if the shaped charge was located off center, the cut could be made at one end of the thin flat section and cause the rolled effect. In the new design the 0.060 inch long thin flat section does not exist, thereby eliminating the tendency to roll. In addition, a more accurate location of the shaped charge with respect to the groove is made, thus assuring that the strap is cut at the thinnest point. The rolled edge was not seen on the tension ties of test LA-4B with this new design.

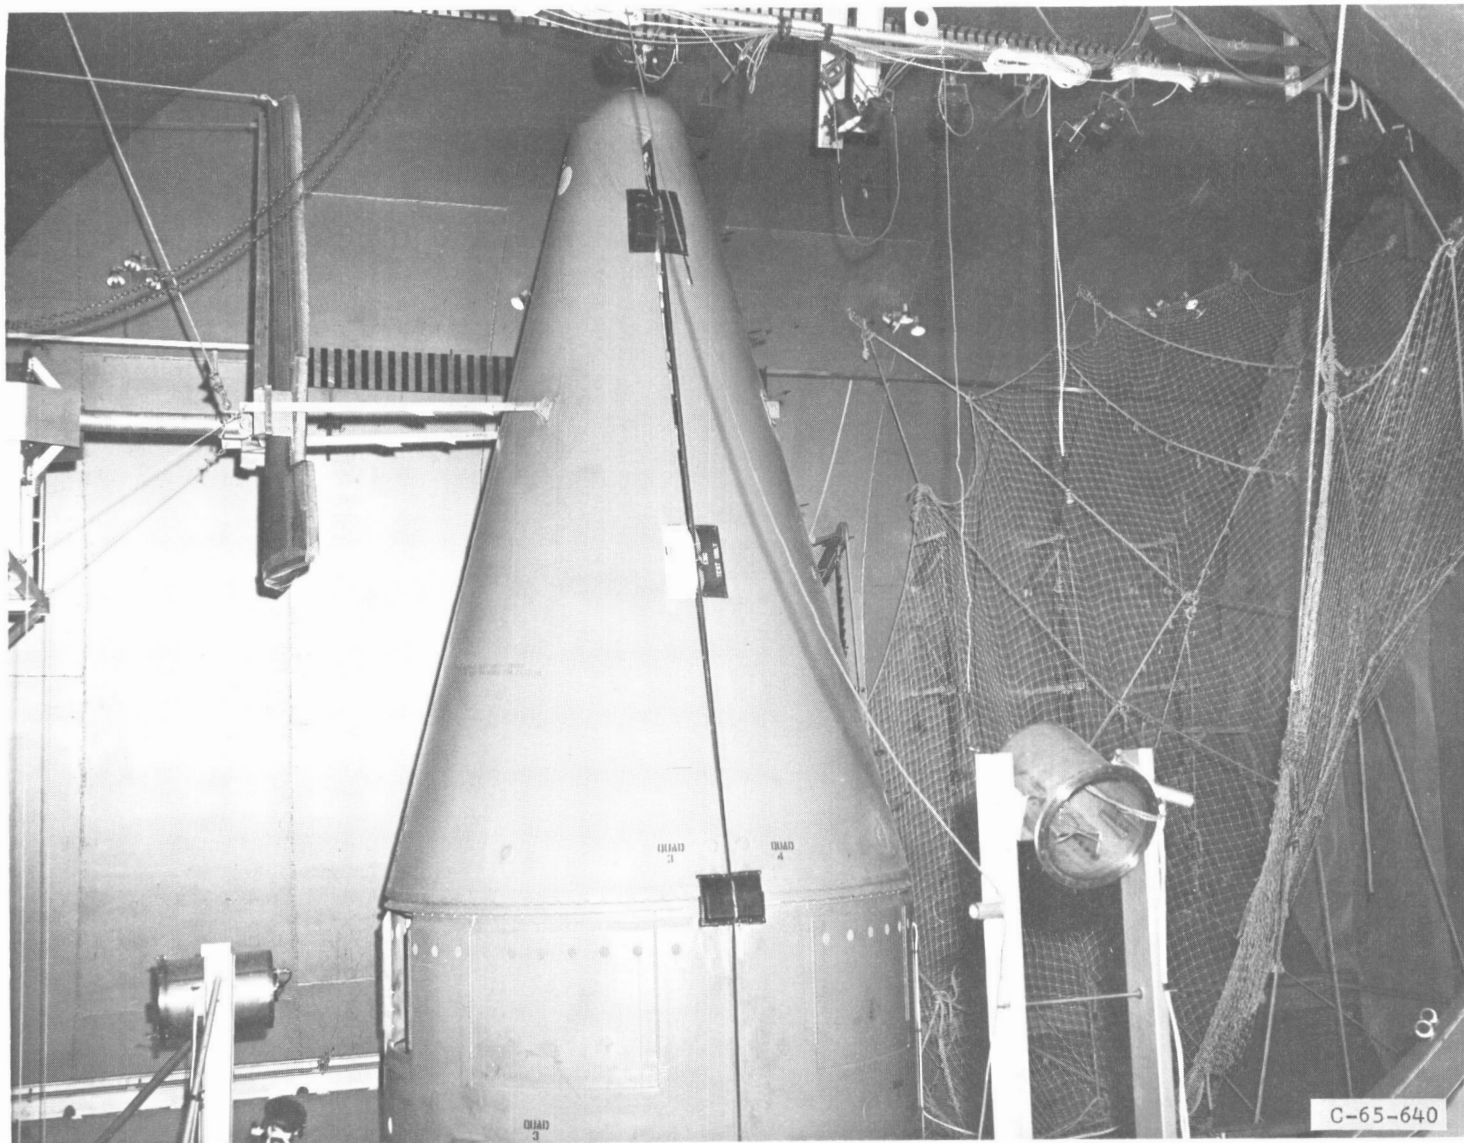
Figure 35. - Gap between fairing halves after the latch separation, test 1A-1A.

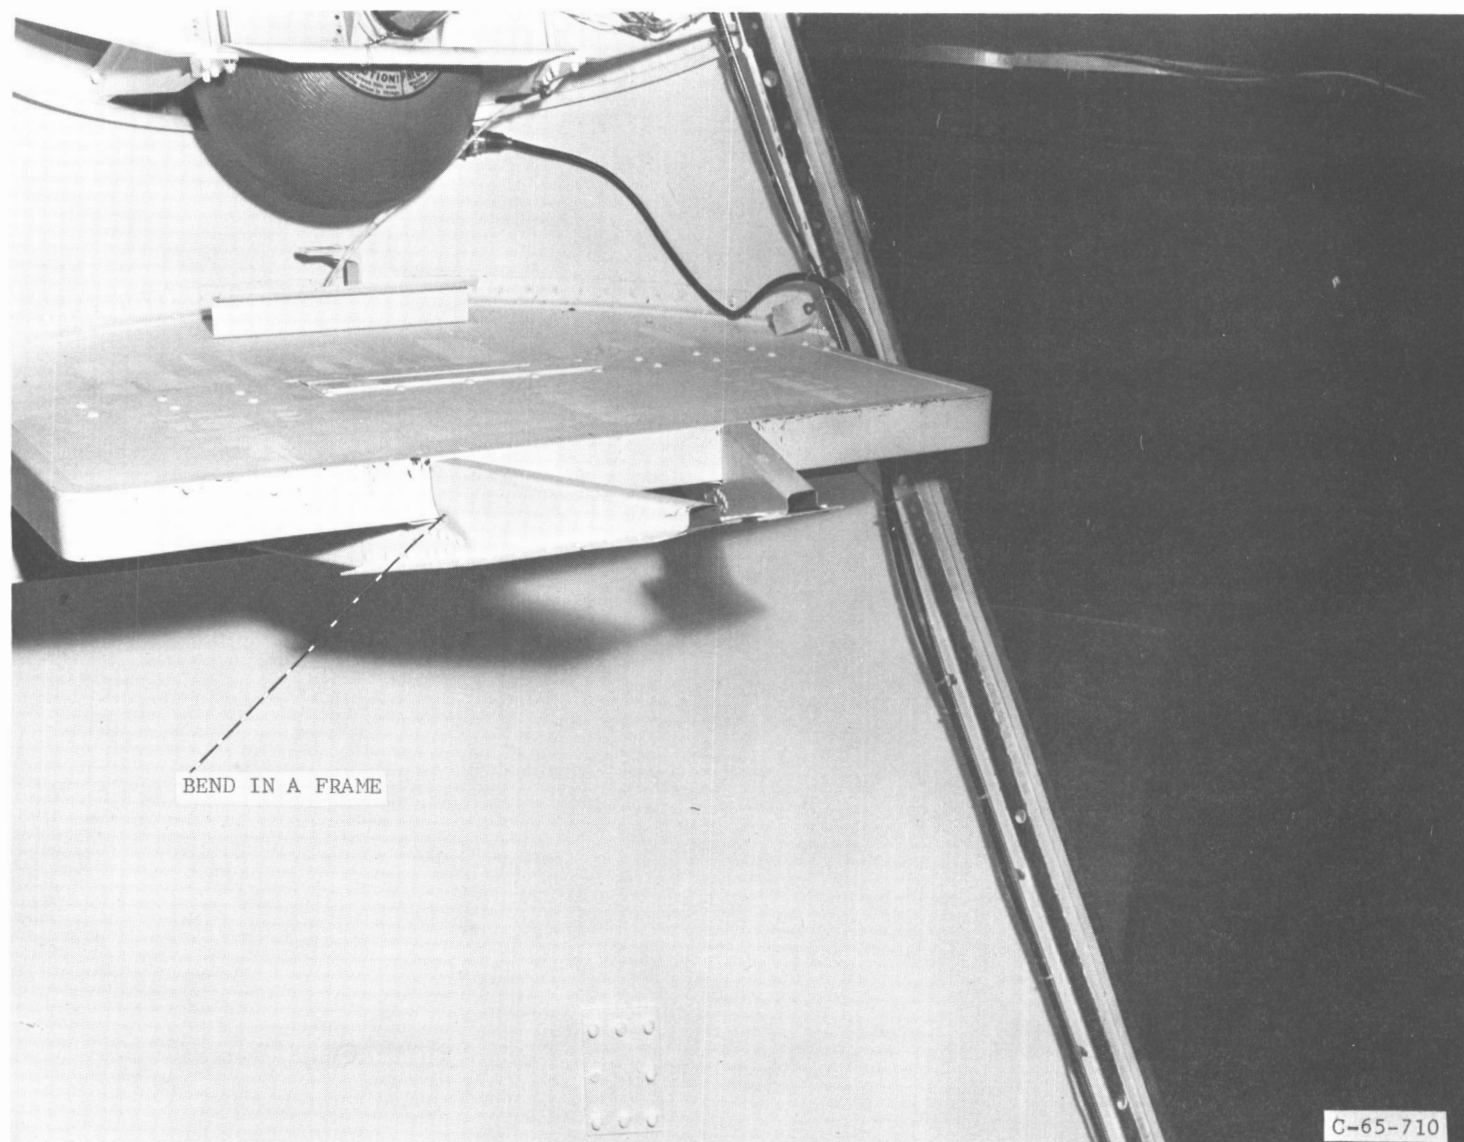
Figure 36. - Damage to the deflector bulkhead A frame, test IA-1B.

The bent deflector bulkhead A frame was removed, a new part was riveted to the A frame assembly, and the whole assembly was then replaced. The gasket on the payload adapter air conditioning disconnect was glued to the male part of the disconnect instead of the female part. The current measuring circuit of the pyrotechnic electrical system was altered by placing relay contacts in the circuit so that current could not be measured until the arming circuit was energized as shown in the wiring schematic, figure 22. The flight hinge was relocated so that no gap existed between the top of the tank half of the hinges and the bottom of the 218.90 splice plate, and a gap of 0.070 inch between the bottom of the hinge pin and the hinge socket was set.

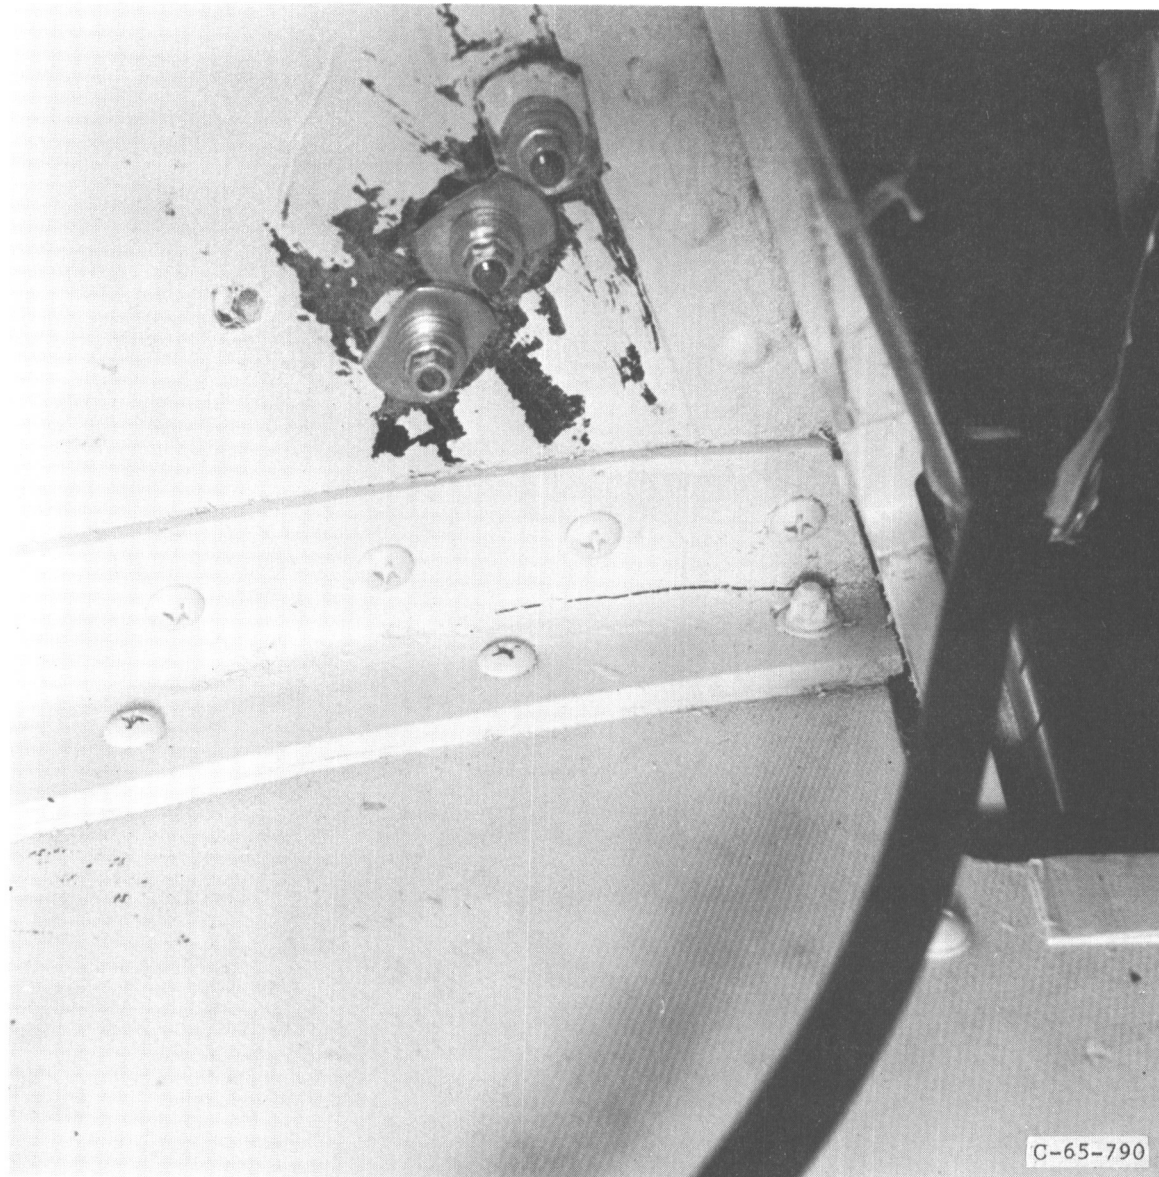
Figure 37. - Crack in the deflector bulkhead on supporting angle, test IA-1B.

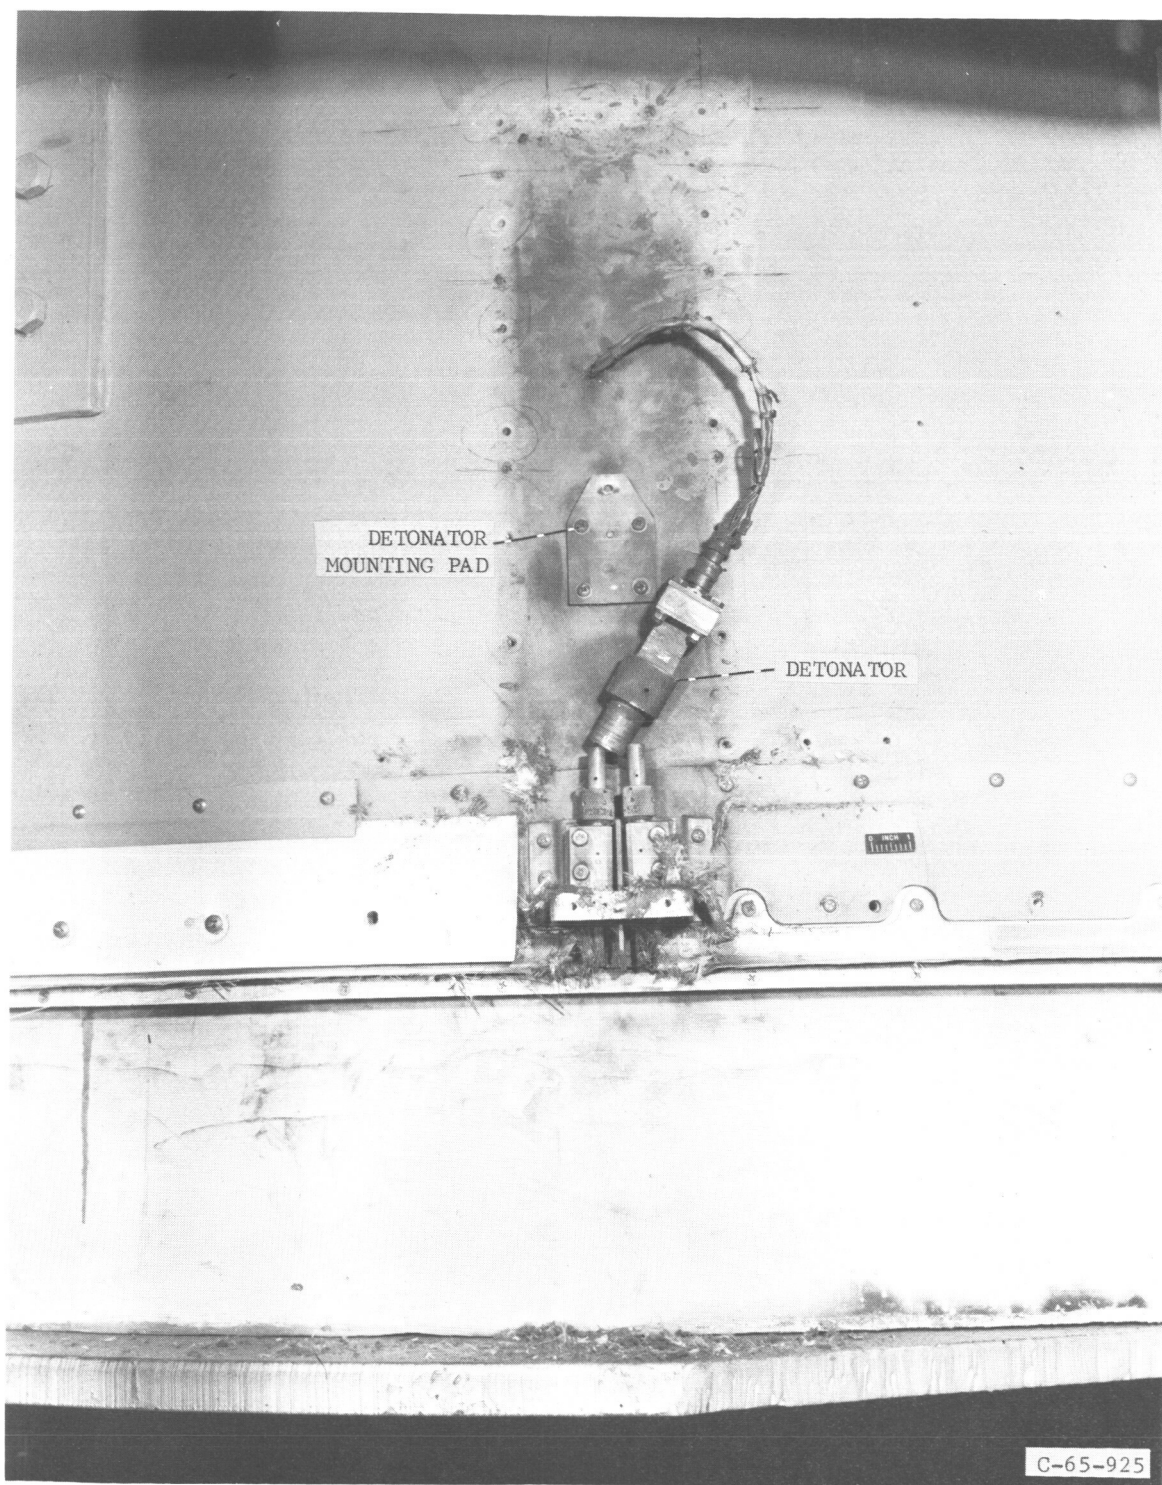
Four new nut plates on the barrel section channel were installed and the shaped charge was installed without a seal under the tension tie. A new skirt was used for this test because of damage to the original skirt. A strengthened detonator fairing was installed over each detonator. The shaped charge was fired at 108,000 feet altitude pressure, and the tension strap was cut all along its length. Again the cut left a turned over edge which in some places was broken in two places so as to form a loose sliver of metal as shown in figure 42. Bolts and the inserts of the skirt assembly were loosened or completely pulled out in numerous places. Figure 43 shows the skirt damage for all shaped charge tests. Three bolts in the detonator fairing were also loosened. The detonator was completely separated from its mounting pad as shown in figure 44.

Figure 44. - Detonator shown separated from the mounting pad as a result of test LA-2A.

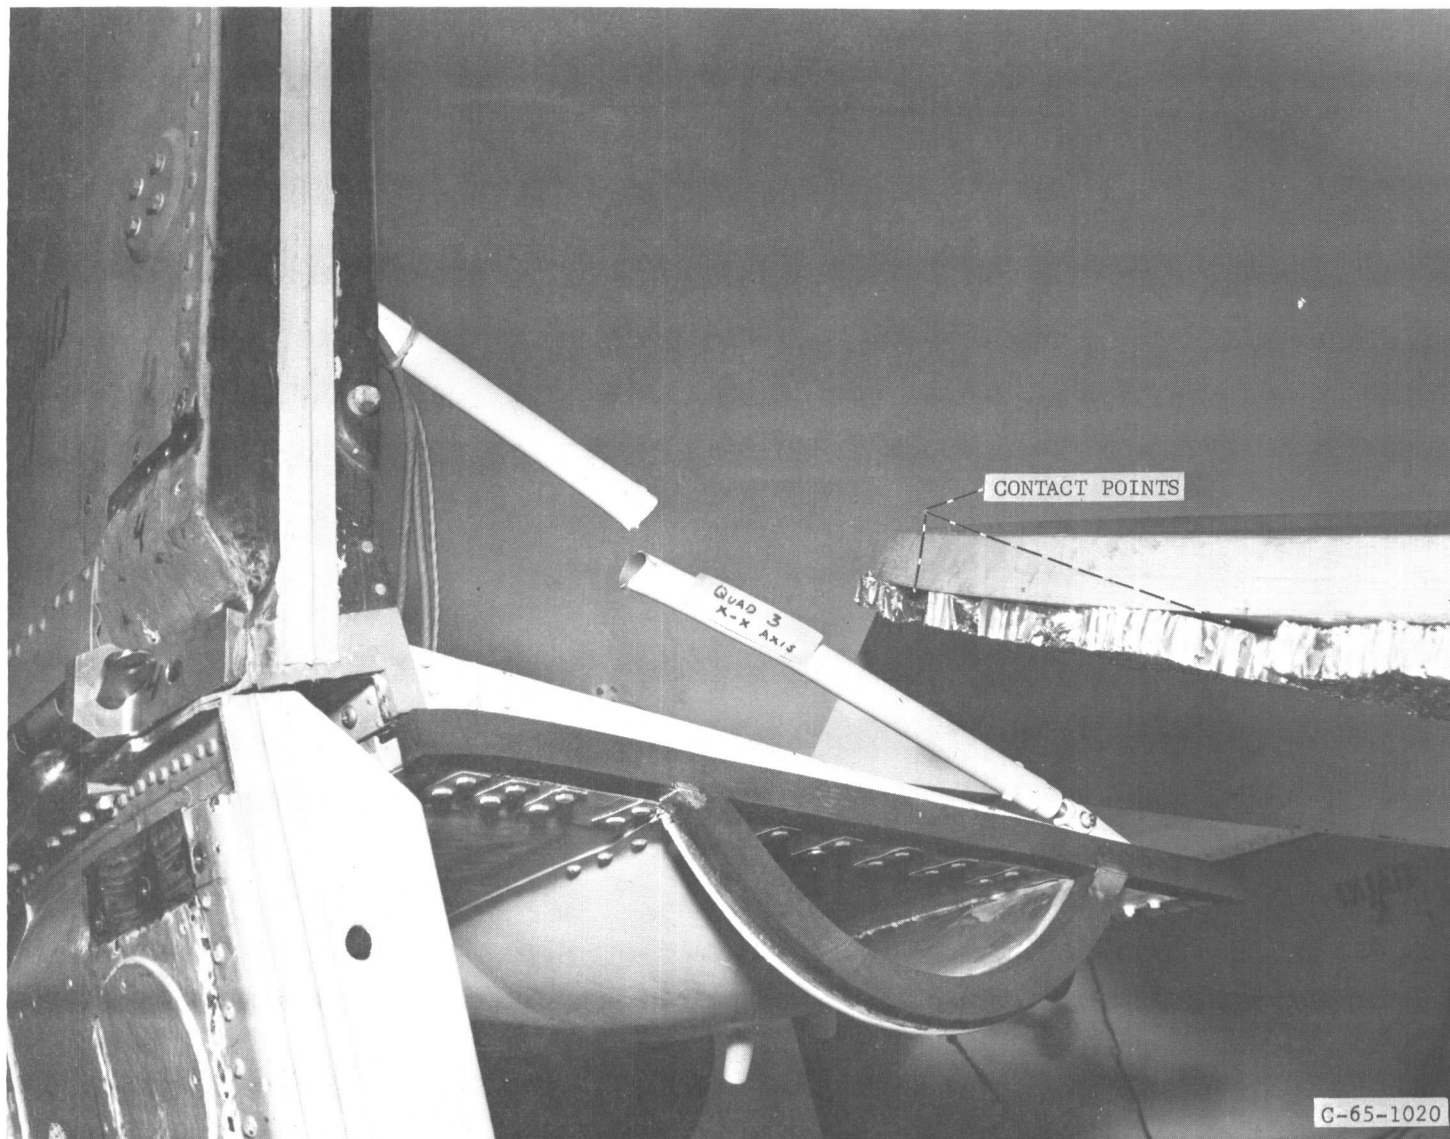
Figure 45. - Broken thermal bulkhead strut, test IA-2D.

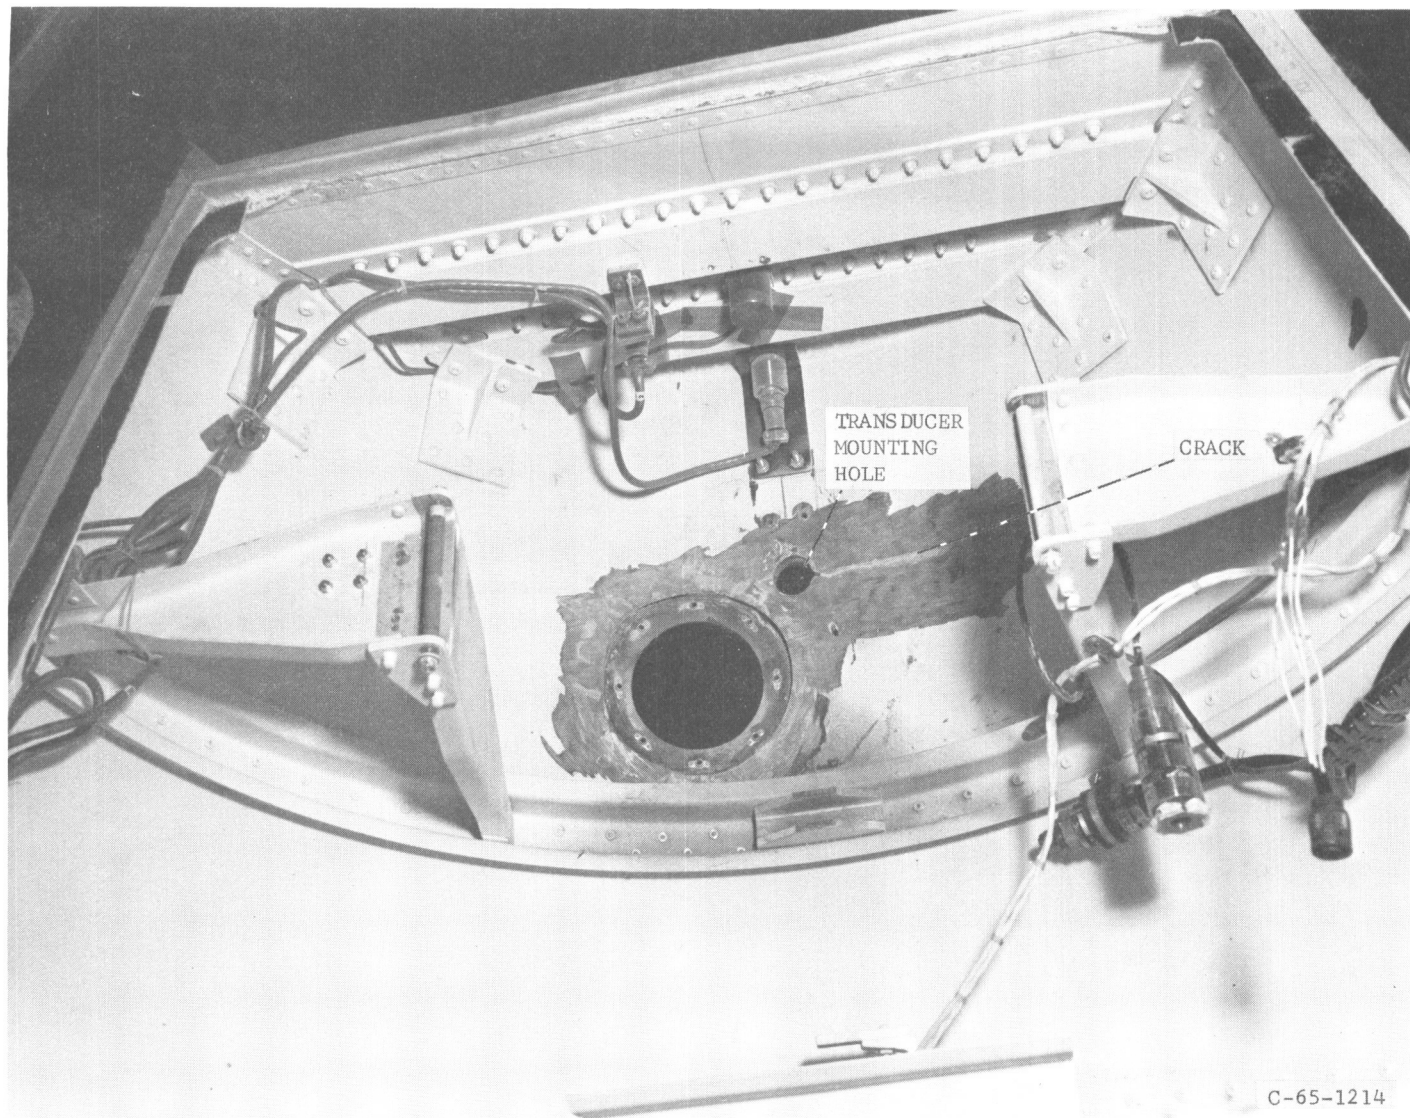
After making this change to the fairing, evacuation was started. At a pressure equivalent to an altitude of 351,000 feet separation was initiated. The fairing wall in the area of the newly installed pressure transduced measuring jettison bottle total pressure on the II-III fairing wall was cracked. Examination of the catcher shoe revealed that the bracket and transducer on the outside of the fairing did not hit the catcher in the honeycomb cutaway area and thus transmitted highly concentrated impact loads to the fairing structure. Figure 49 shows the crack in the fairing wall caused by the forces transmitted by the transducer. Figure 50 shows the misalignment of the transducer contact point and the space provided for it on the catcher pad.

Figure 49. - Crack in fairing wall caused by the transducer contact with catcher, test 1A-3.

Repair of the damage to the nose cone structure in the area near the jettison bottle pressure transducer was accomplished by filling the honeycomb interior of the wall with the mixture of Epon 828, Versamid, and hardener through holes in the exterior skin. Three layers of fibre glass cloth were then glued over the exterior skin.

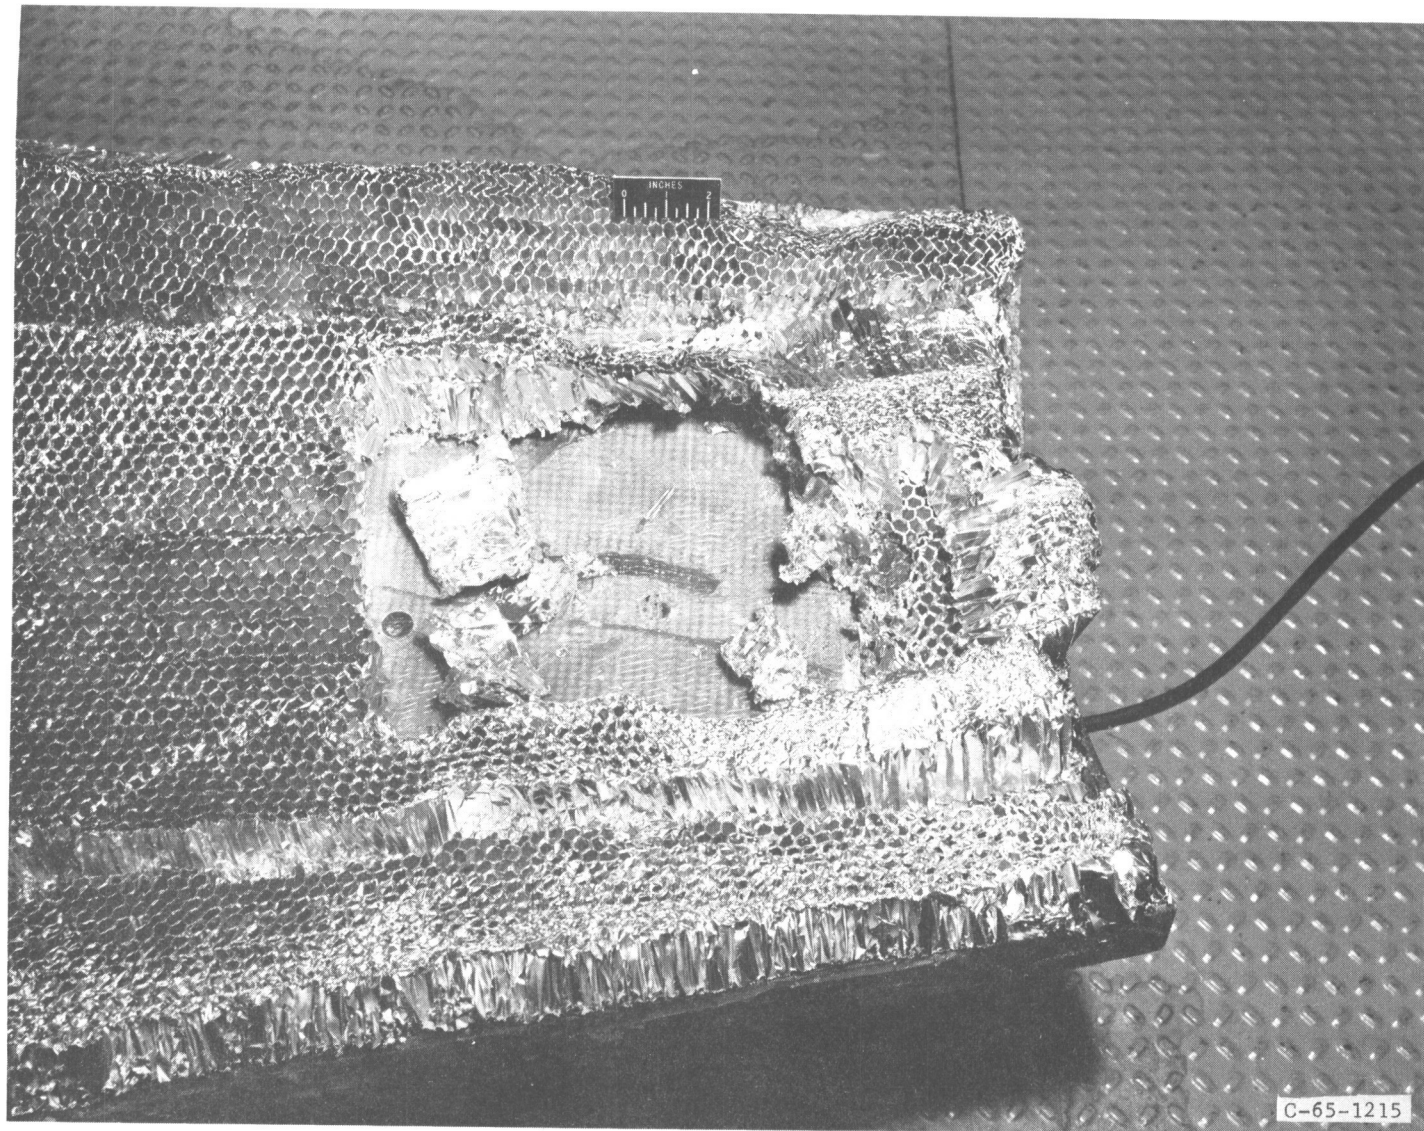
Figure 50. - Catcher after damage to fairing, test IA-3.
